## Natural Heritage Impact Study

## FINAL REPORT

# Natural Heritage Impact Study for the Redevelopment of Ontario Place

Presented to:  
**Infrastructure Ontario**

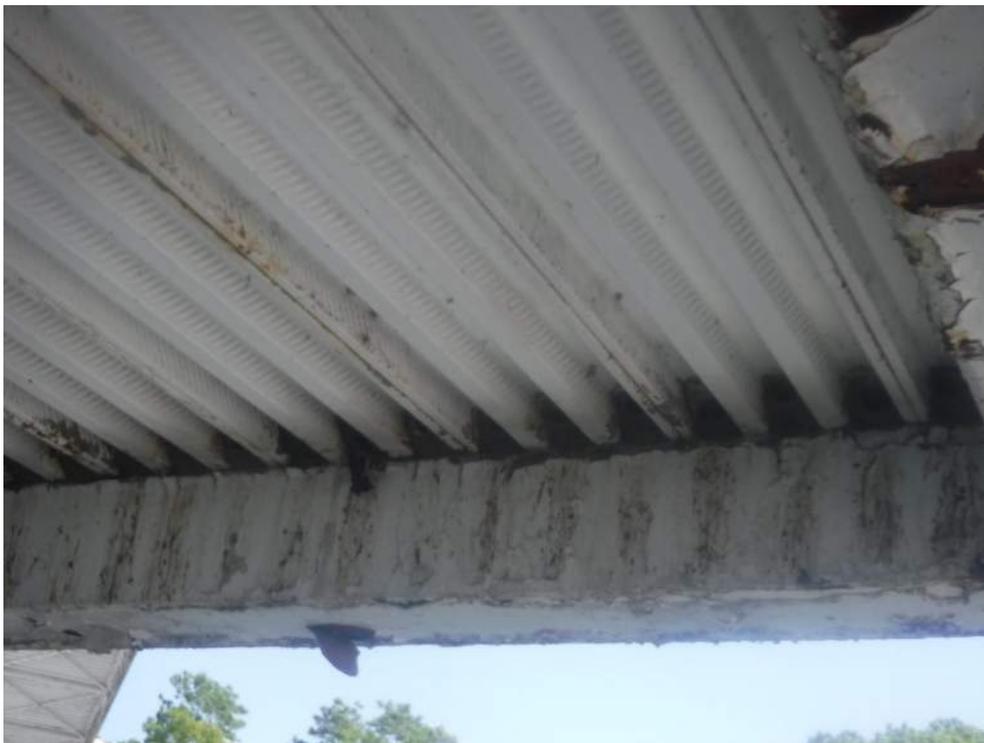
Figure 80: Close-up example of the metal grooves in underside of the Pavilion Pods (B92549 - 1-5) that provide Cliff Swallow nesting habitat. Cliff Swallow nests are visible in the end of each groove. June 16, 2022.

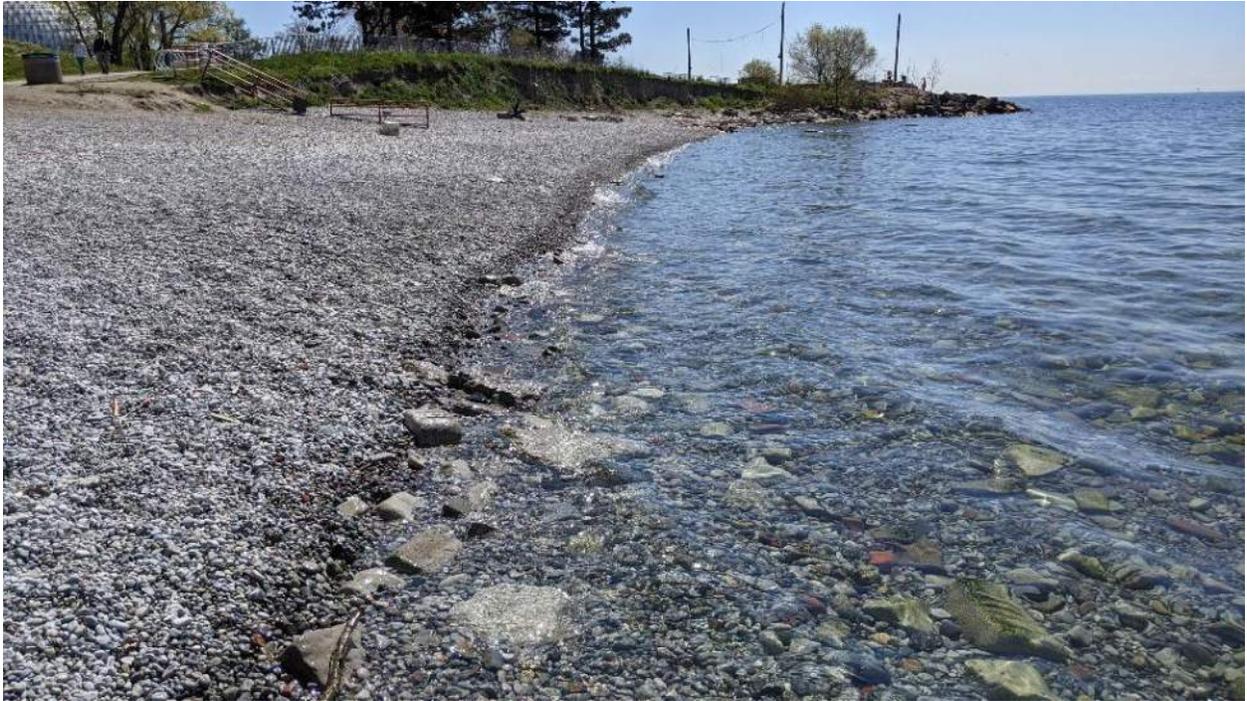
Figure 165: View of WIS-1 - Open Water Beach Shoreline habitat. May 14, 2021.

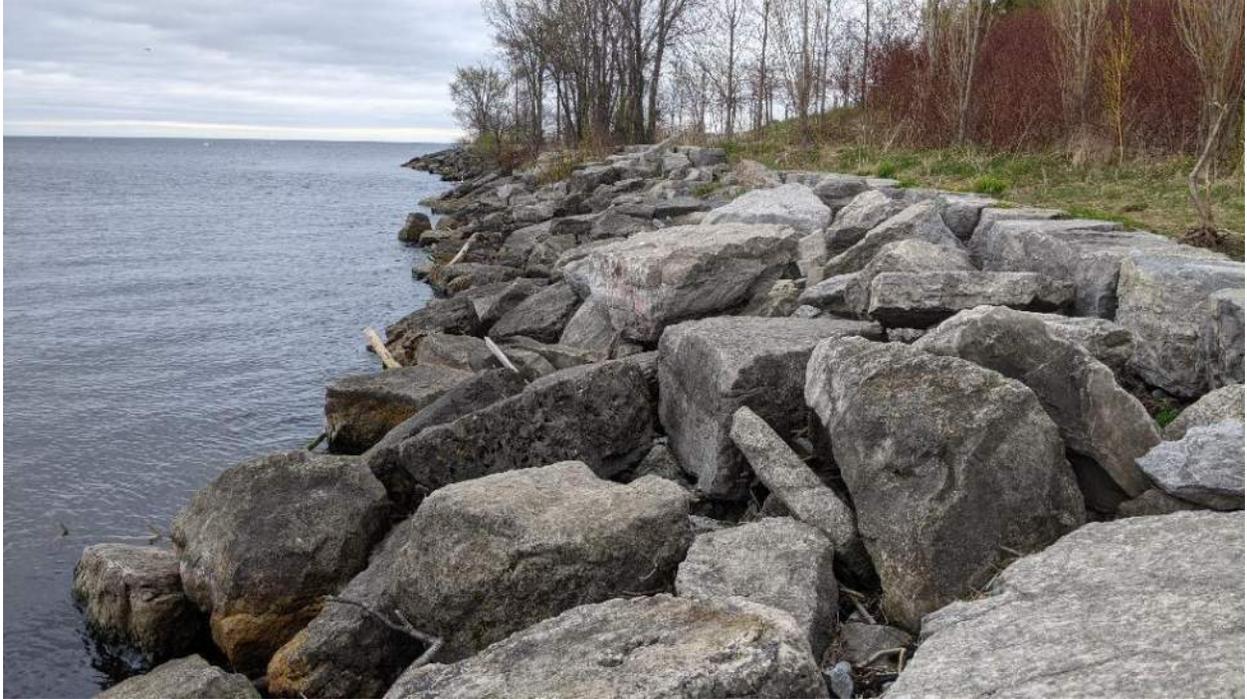
Figure 167: View of EIS-1 - Open Water Protected Sloped Shoreline habitat. May 5, 2021.

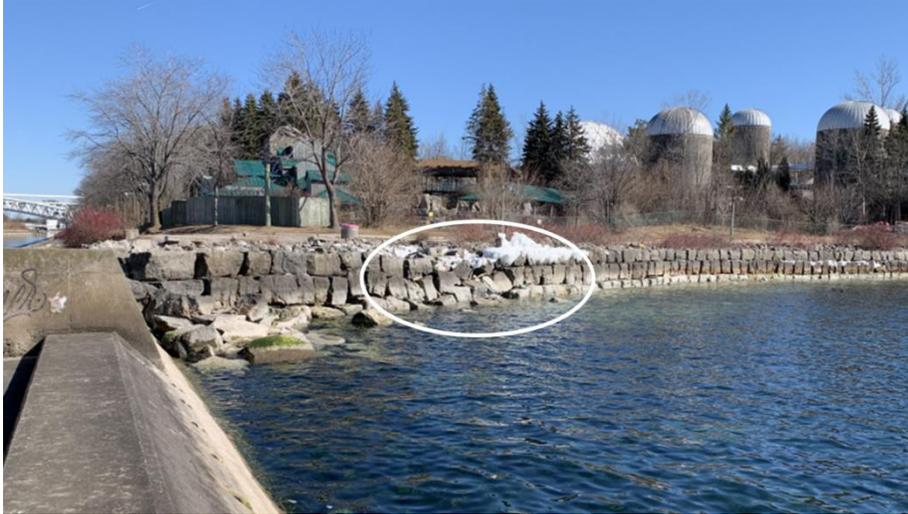
**Figure 8: Collapsed portion of stacked armour stone seawall at west shore**

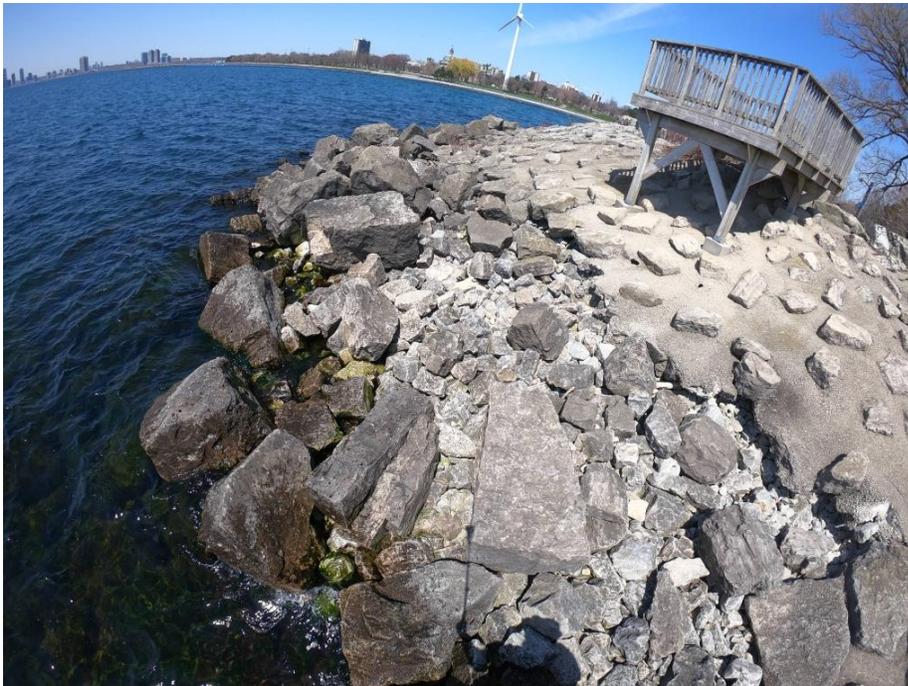
**Figure 9: Damaged armour protection at west headland (Baird 2022-04-29)**

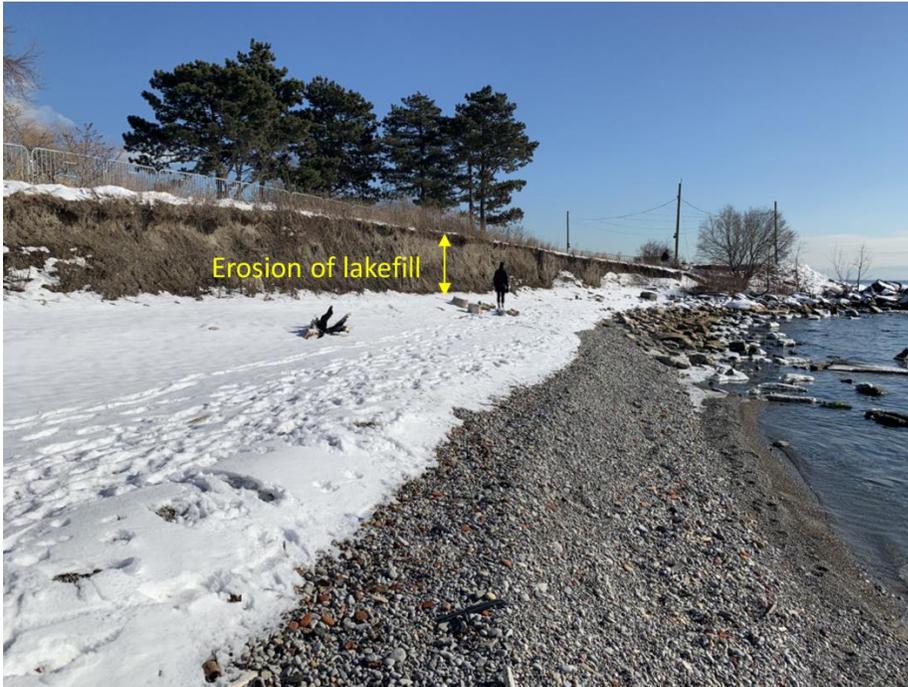
Figure 10: Significant erosion of lakefill at south shore (Baird 2021-01-30)

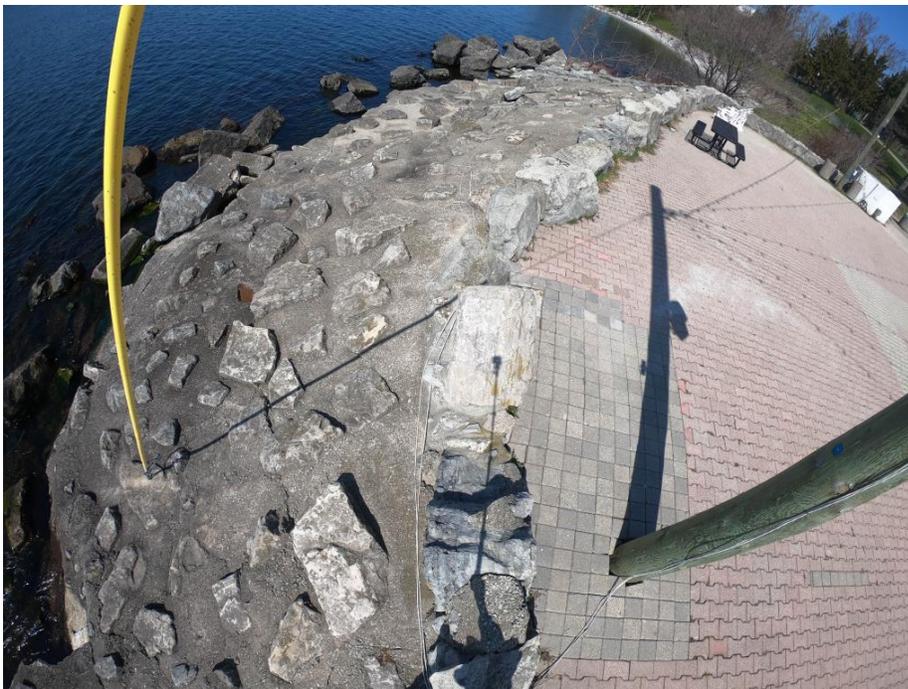
Figure 11: View of deteriorated grouted revetment at east headland (Baird 2022-04-29)

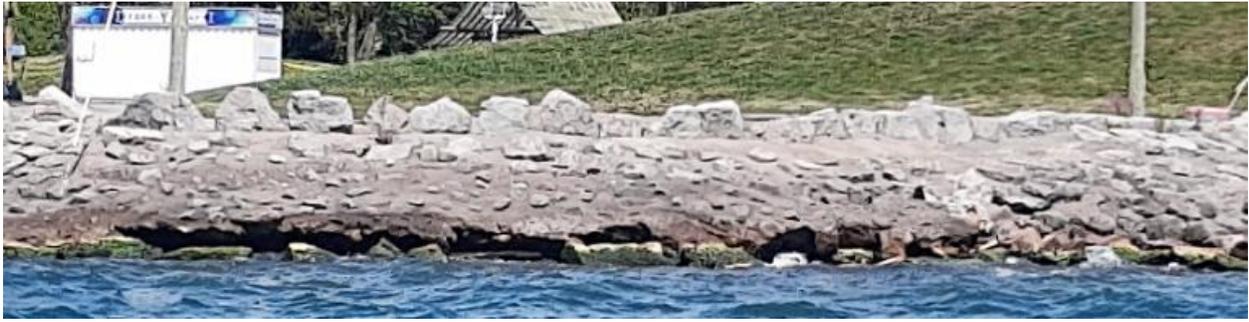
**Figure 12: Deterioration of grouted stone revetment at east headland (from Jacobs, 2020)**
